# COMPLETION REPORT

## TRANSDUCER CALIBRATION PLATFORM (TCP) MOORING

NAVAL UNDERWATER SYSTEMS CENTER,  
SENECA LAKE DETACHMENT  
DRESDEN, NEW YORK

FPO-1-83 (33)

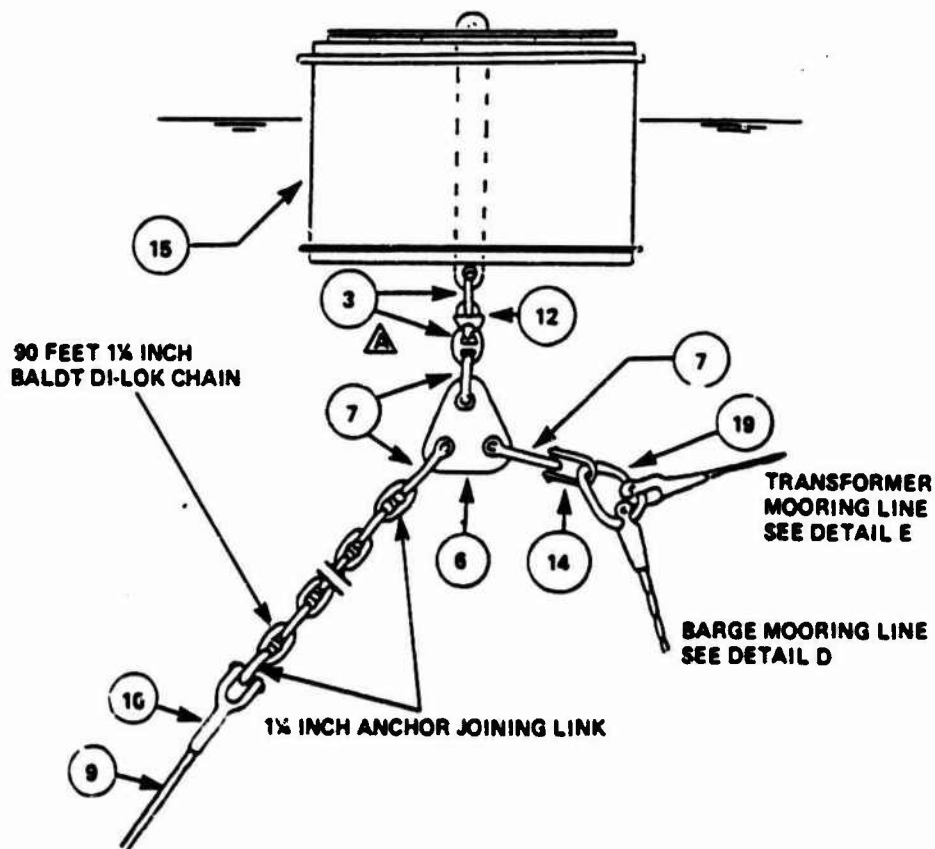
FIGURE 31  
"AS BUILT" DETAIL SKETCH  
OF MOORING BUOY LEG NO. 2

However, due to the northeast mooring being an estimated 85 feet short, the contractor was instructed to add one shot (90 feet) of 1 1/4-inch Baldr DI-Lok chain between the towing plate and the open swage fitting on the buoy end of the 1,100-foot length of riser wire (see Figure 31 and Detail G of the "as-built" drawing).
